Effect of friction stir weld defects on fatigue lifetime of an Al-Cu-Li alloy (AA-2198)

T. Le Jolu, T.F. Morgeneyer, A.F. Gourgues-Lorenzon
MINES ParisTech, Centre des Matériaux, CNRS UMR 7633, BP 87, 91003 Evry
cedex, France

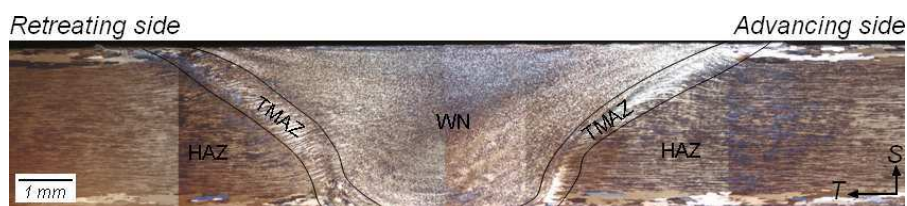
Fig. 4: Light optical micrograph of a JLR-free weld

The base material showed pancake shaped grains lying in the L-T plane (Fig. 3). Thicker recrystallised grains were observed close to the sheet surfaces. Three zones were identified in the weld from optical microscopy observations (Fig. 4): the Weld Nugget (NG) is composed of fine equiaxed grains of typical size between 5 and 10 μm ; the Thermo-Mechanically Affected Zone (TMAZ) is composed of highly deformed grains; the Heat Affected Zone (HAZ) has the same grain structure as the base material.

In the JLR-free weld (Fig. 4), no defect, such as JLR, porosity or cracks was observed at any weld location. In the material welded after natural oxidation, a JLR can be seen (Fig. 5) as a discontinuous zigzag curve of oxide particles through the sheet thickness.
